# KINNER SERVICE BULLETINS

SUBJECT: FLOAT NEEDLE SEATS NA-R5, NA-R5A, NA-R6  
STROMBERG CARBURETORS

**AIRCRAFT CARBURETOR SERVICE BULLETIN NO. 32**  
**LOCKING FLOAT NEEDLE SEATS**  
**IN NA-R5, NA-R5A AND NA-R6 CARBURETORS**

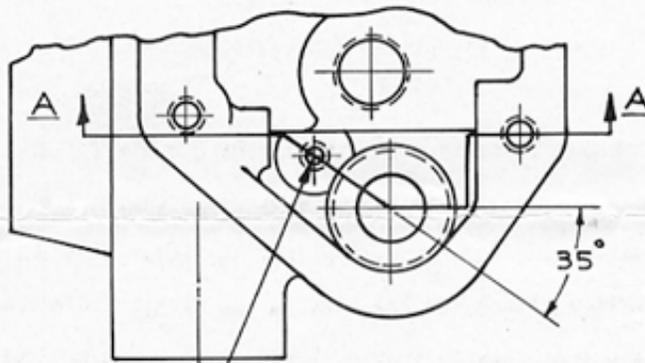
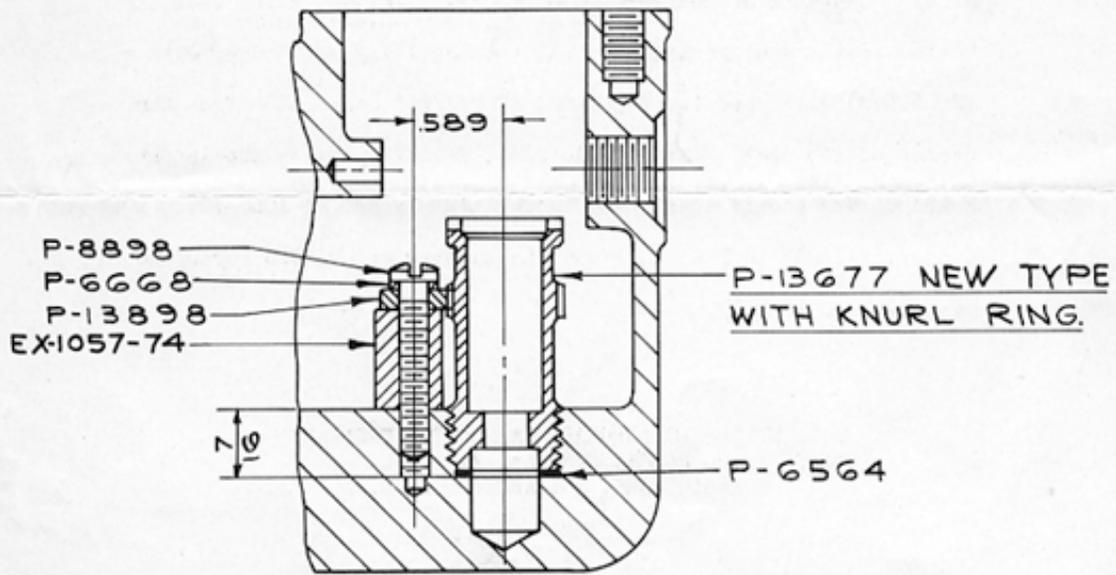
### INSTRUCTION CHART #1077

Because there is a possibility of old style float needle seats in NA-R5, NA-R5A, and NA-R6 Carburetors coming loose in service, resulting in the engine stopping, the later carburetors have been provided with a knurled ring on the float needle seat and a lock clip and screw to prevent the seat from coming loose.

1/2 DIA. C'BORE TO 7/16 DIM.  
#25(.149) DRILL 9/16 DEEP &  
#10-24 NC-2 TAP 7/16 DEEP.

Old style carburetors which do not incorporate the lock clip may be reworked in accordance with the attached sketch so that a locking device may be used with a new seat. This reworking consists of counterboring to the 7/16" dimension from the bottom of the seat gasket surface, then drilling 9/16" deep with a #25 (.149) drill and tapping #1024 NC-2 7/16" deep .589" from the center of the seat. A new style Seat, P-13677, having the latest knurled ring should then be assembled tightly and EX-1057-74 Spacer, P-13898 Lock Clip, P-6668 Lockwasher and P-8898 Screw should be assembled tightly.

INSTRUCTIONS FOR ADDING LOCKING CLIP TO FLOAT NEEDLE SEAT ON NA-R5, NA-R5A & NA-R6 CARBURETORS IN SERVICE.

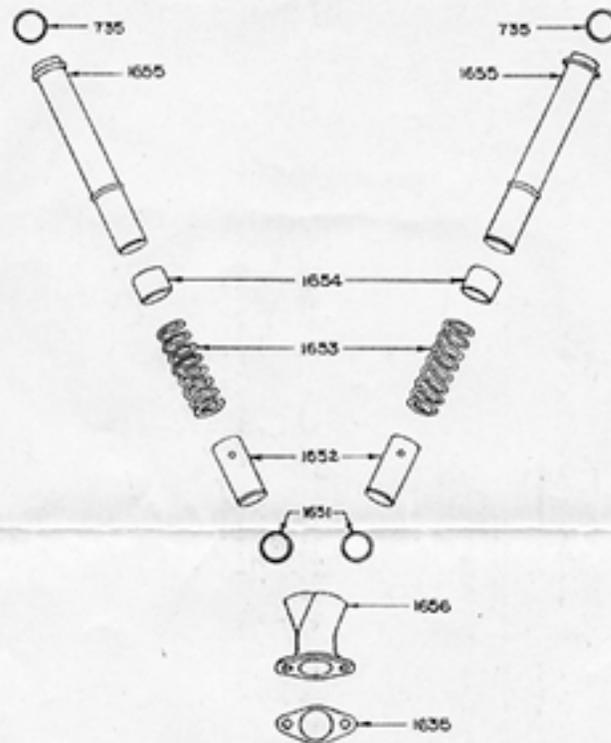
It has been brought to our attention that difficulties have been experienced with the old style push rod housings, wherein the housing spring or housing has become bent in such a manner that the push rod rubs the spring with the consequent wearing of the push rod. To forestall any future difficulties that might arise from this old style push rod housing assembly, we are recommending that the new and improved type push rod housing, as is used on the present R-55 engine, be substituted for the older type. To make this change, it will be necessary to use the parts as shown in this bulletin.
